FINAL
CONNECTICUT RIVER BASIN
WHATELY, MASSACHUSETTS

NORTHAMPTON RESERVOIR
(LOWER DAM)
MA 00520

PHASE I INSPECTION REPORT
NATIONAL DAM INSPECTION PROGRAM

AUGUST 1978

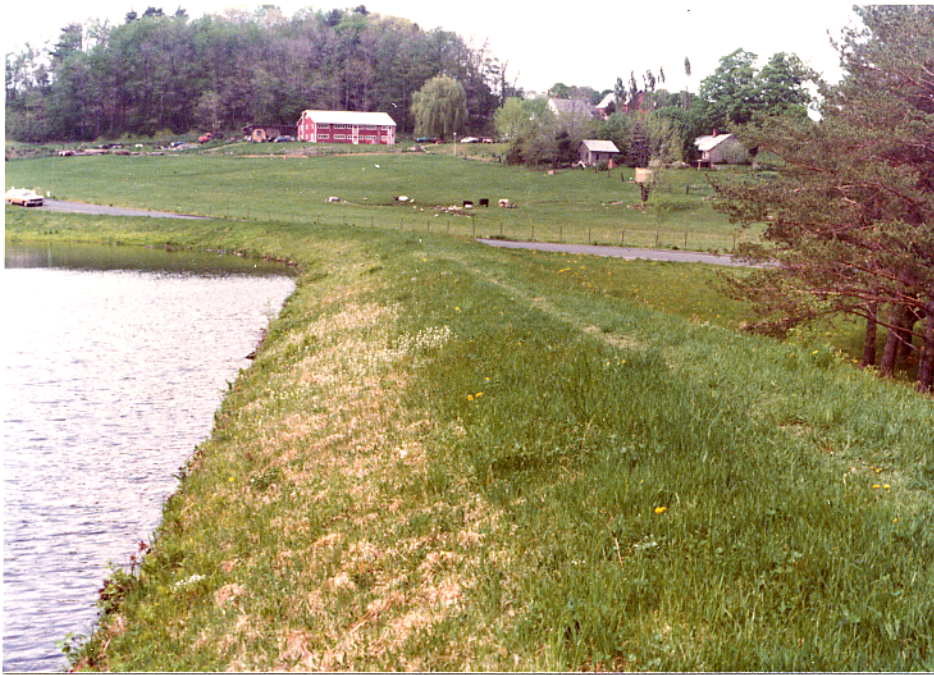
The riprap protection has been infilled with soil and grass but is in place. No surface erosion was noted on the upstream slope.

PHOTO NO. 1 - Upstream face from gate house to
left abutment.

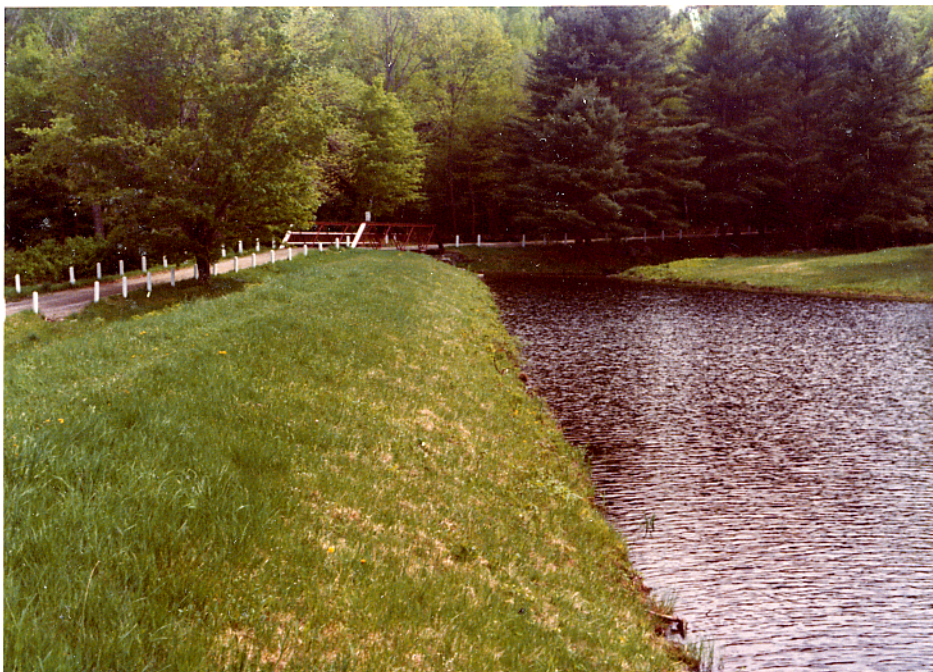
PHOTO NO. 2 - Upstream face from gate house to
right abutment.

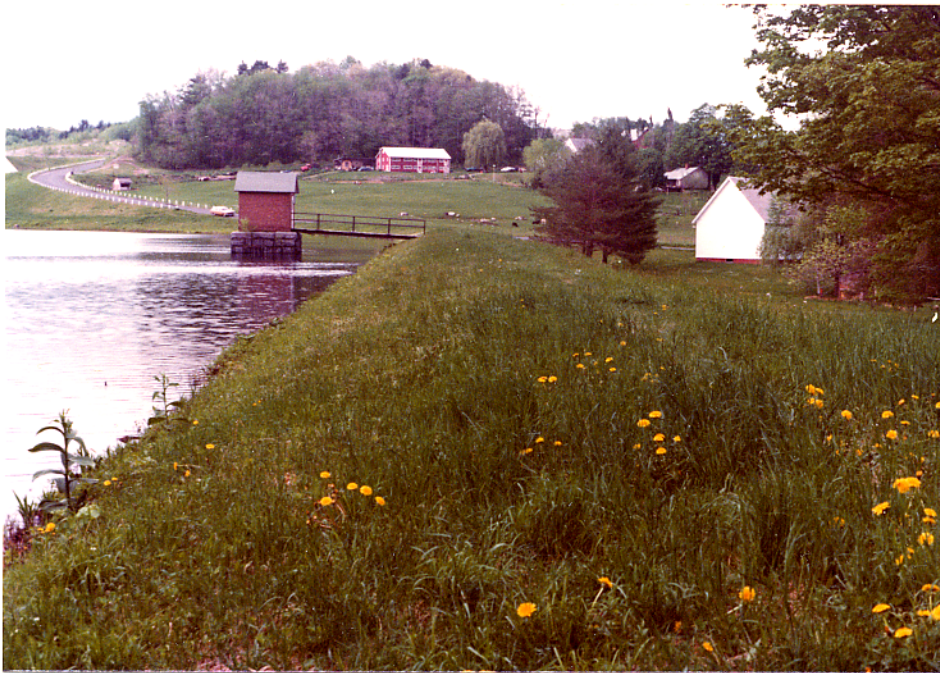
PHOTO NO. 3 - General view of dam from spillway
looking toward left abutment.

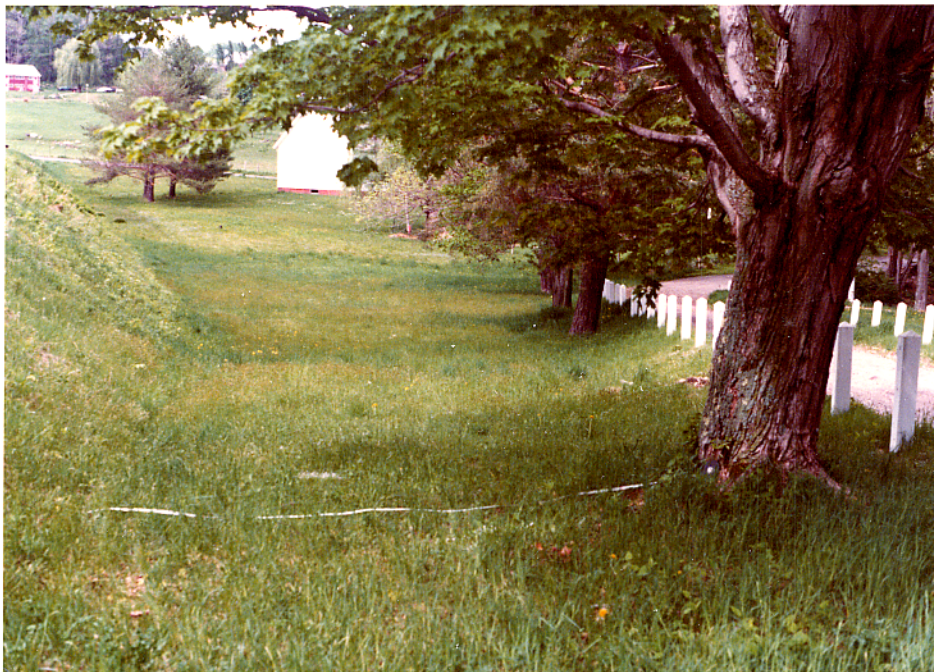
The slope is in good condition with a good turf and grass cover. There are small bushes up to 3 feet high growing on the slope which should be removed as part of normal dam maintenance. The owner normally cuts the grass and cleans the slope each spring; our inspection was performed before this routine maintenance had been performed.

PHOTO NO. 4 - Downstream face showing proximity of
large trees to toe of dam. The nearest
tree is 13 ft. from toe of dam.

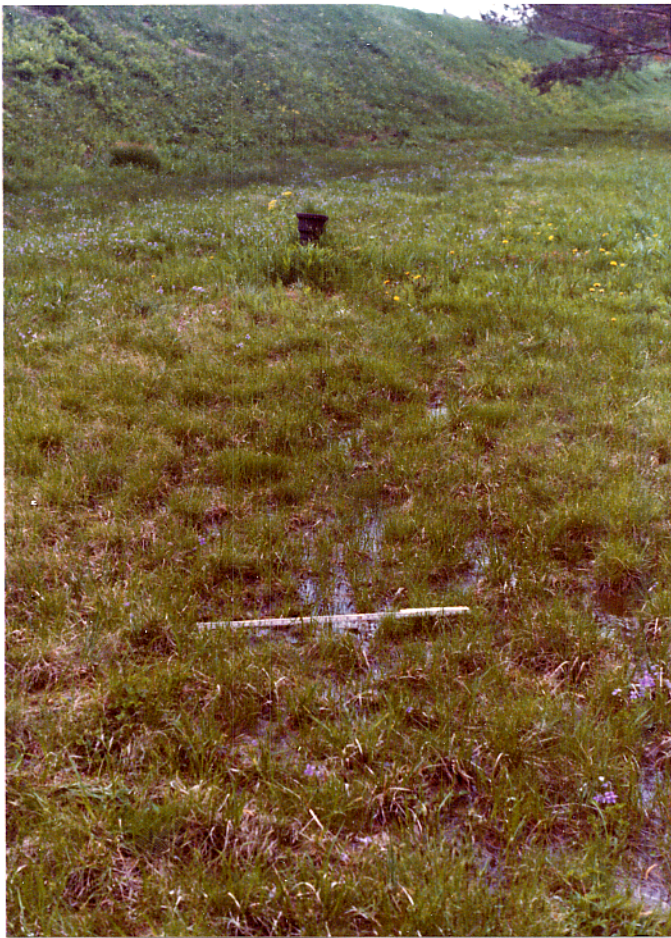
There is a large area immediately downstream of the dam which has standing water due to seepage from the dam or its foundation. The extent of this area can be seen in Photo 5. The area extends about 200 ft. along the toe and proceeds downstream to the Williamsburg Road in an approximately triangular pattern with the base of the triangle at the dam toe.

This seepage area has been noted in early reports dating to 1970. Mr. Leon Murray of the Northampton Board of Public Works has indicated that this seepage condition has existed since he joined the Board in the 1940's.

The extent of the seepage from this dam is large, the fact that the seepage has existed for over thirty years with no visible effect on the dam indicates that the dam is not likely to be an immediate safety hazard. However, present day design standards would not allow such an uncontrolled seepage condition to exist below the dam. It is recommended that the owner engage a qualified consulting engineer to investigate the cause of the seepage and to design a proper collection system downstream of the dam that would allow periodic measurement of the quantity and turbidity of the seepage water.

PHOTO NO. 5 - General view of seepage area at d.s. toe. Pipe in upper part of photo is opposite gate house in the center of the dam.

1) The owner should have a qualified consultant investigate the seepage condition below the toe of the dam and design an adequate collection and monitoring system.

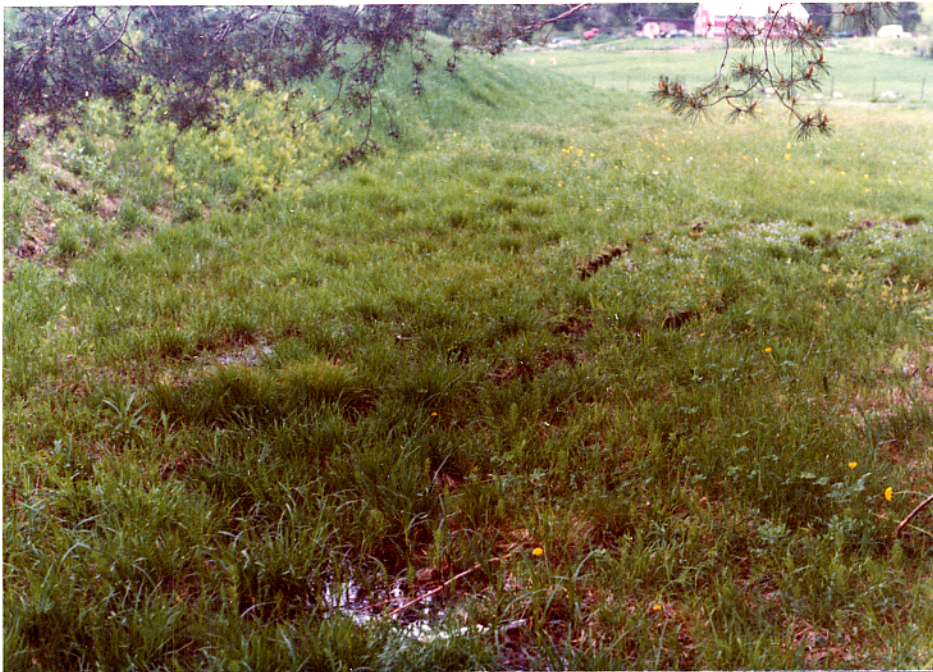
PHOTO NO. 6 - Seepage area near left abutment not visible in PHOTO 5.

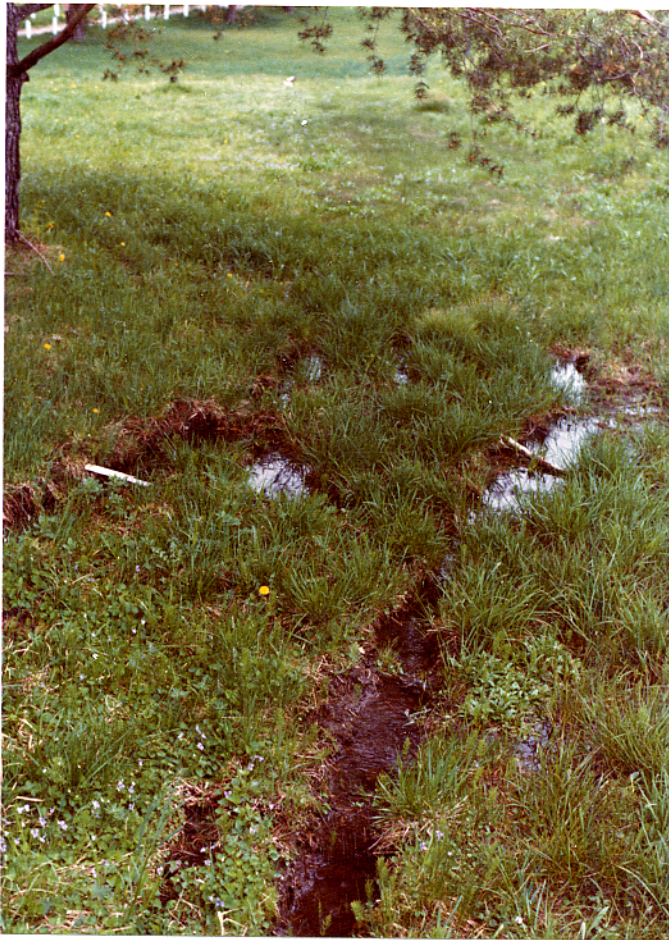
PHOTO NO. 7 - Close-up
of seepage area shown in
PHOTO 6 .

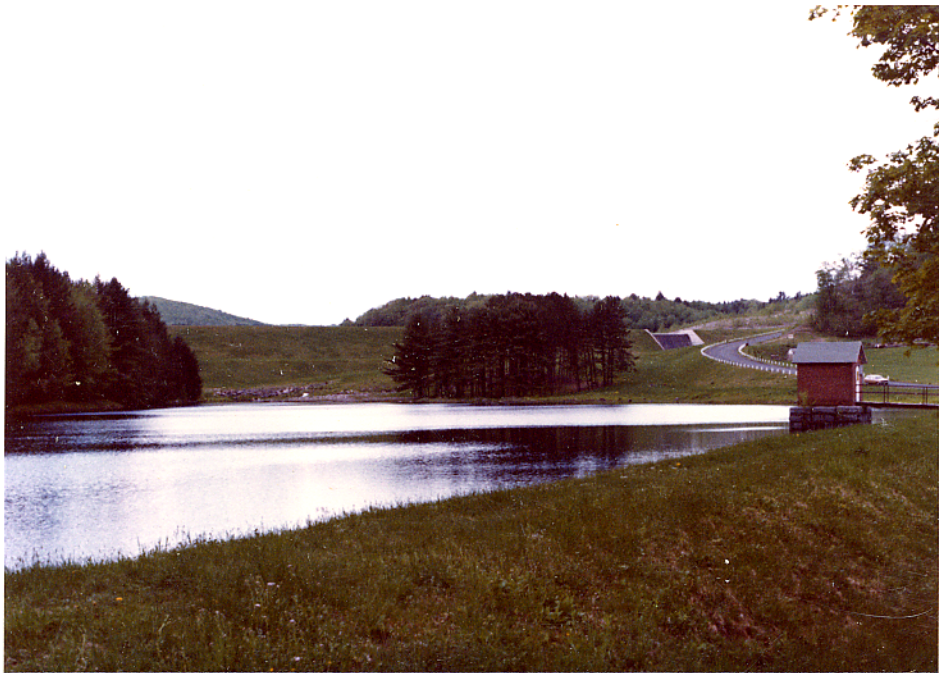
PHOTO NO. 8 - General view of reservoir from right
abutment.

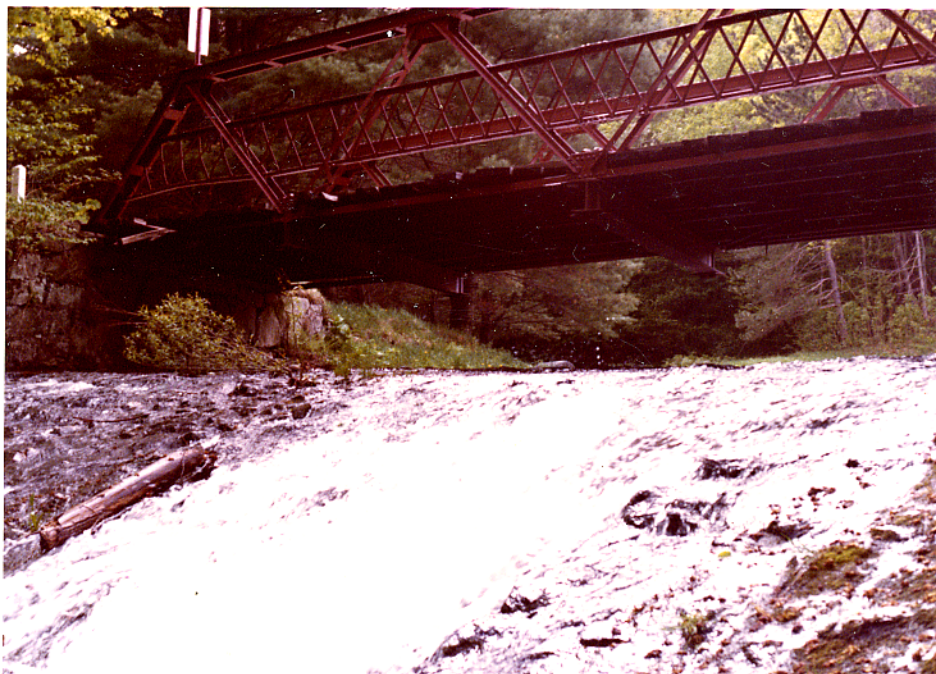
The downstream channel is a natural stream bed, surrounded by wooded area. The stream is flowing freely. The area immediately below the spillway crest is stone and concrete paved. Much of this area is spalled and eroded away. This condition has been reported in past State Inspection Reports. Due to the water flow over the spillway area, it was difficult to determine the underlying material at these locations, and the degree of erosion seriousness at the time of this inspection. Subsequently this area was reinspected on July 6, 1978. At this time no water was passing the spillway. The channel immediately below the spillway is constructed of hand placed boulders which at some date were grouted in place. At many locations the concrete has eroded and spalled away. This has allowed water to dislodge some of the hand placed boulders. This condition however does not pose a serious problem to the safety of the dam at this time. The training walls which serve

PHOTO NO. 9 - Spillway outlet channel.

2) The area of the downstream channel immediately below the spillway as outlined in Section 3.1e of this report should be repaired. This repair should consist of replacing in kind the dislodged hand placed boulders or filling the voids with concrete.

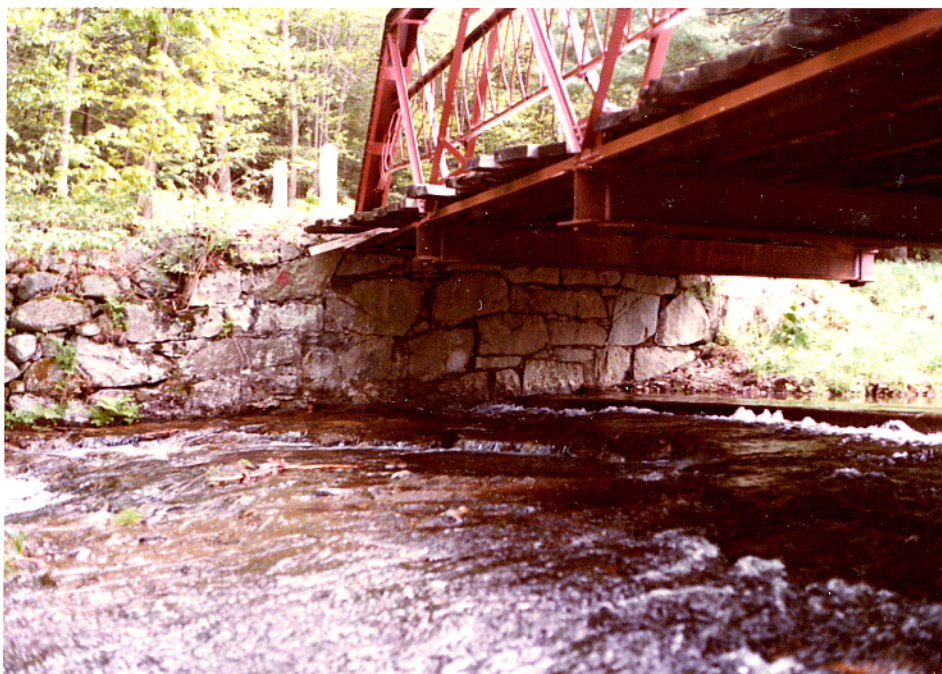
as abutments for the roadway truss bridge are true and plumb and in generally good condition.

PHOTO NO. 10 - Spillway outlet and bridge abutment.

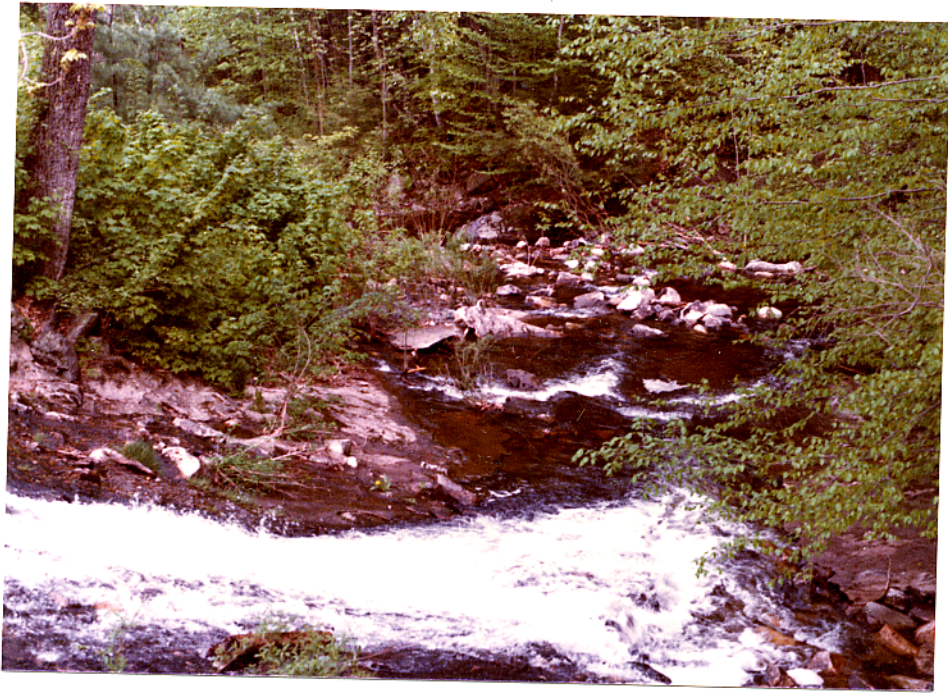
PHOTO NO. 11 - General view of outlet channel
looking downstream.

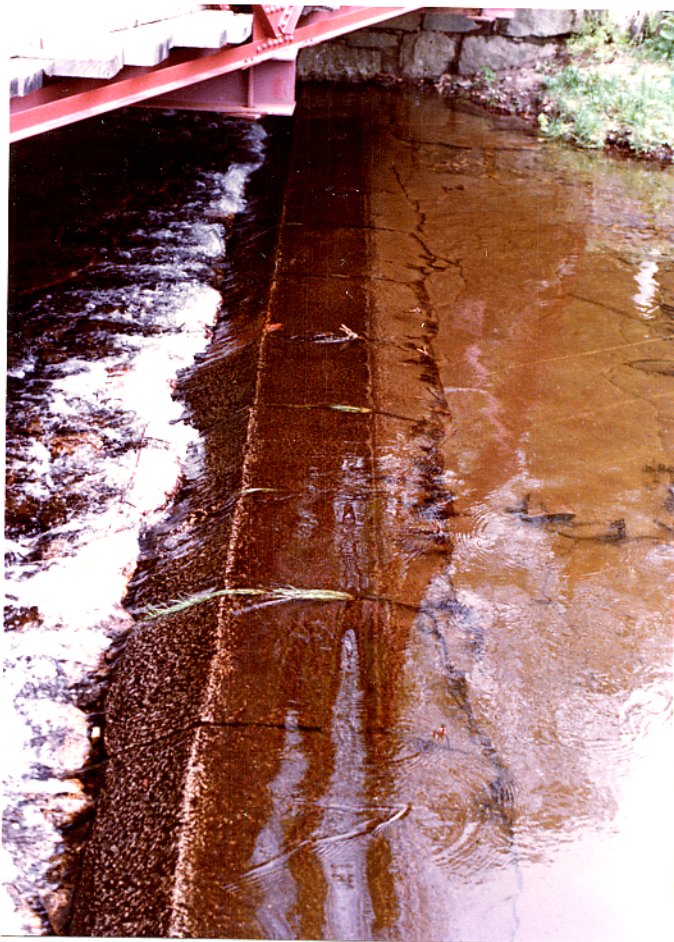
PHOTO NO. 12 - General
view of Spillway crest.

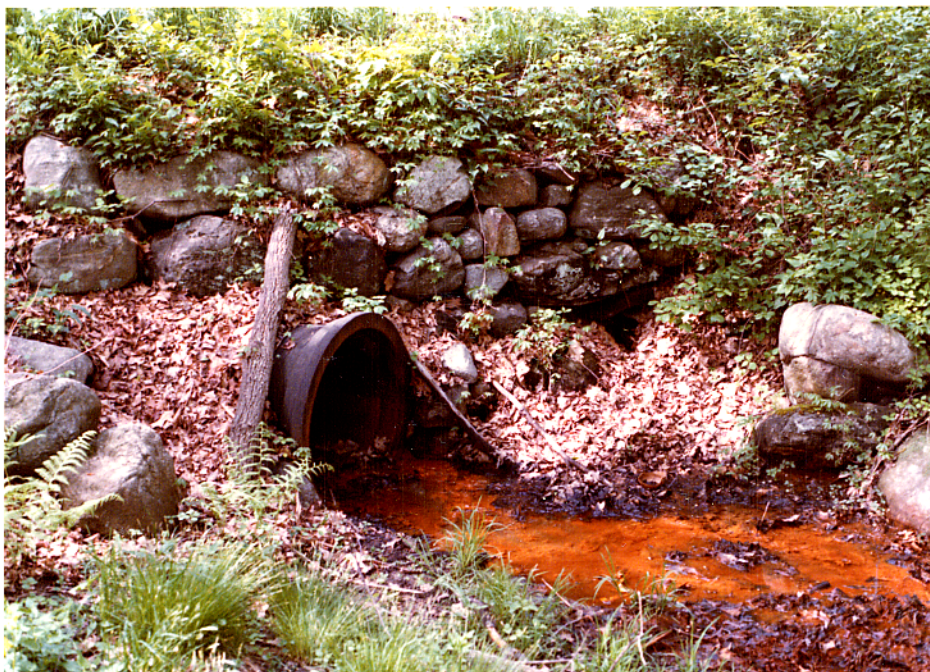
PHOTO NO. 13 - Outlet pipe below dam across
Williamsburg Rd.
